ALVIS WORKSHOP

Three Litre {TA-TC} Clutch and Brake pedal assembly overhaul. Richard Wallach

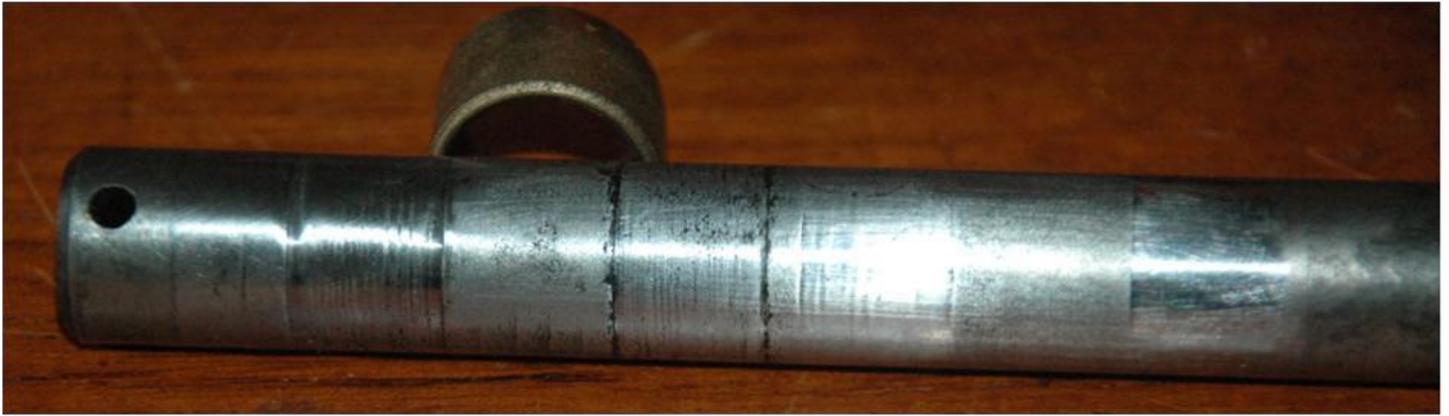
The shaft {I-7} from my TA21- 24314 with a bush behind is shown below. The car has travelled a genuine 91000 miles.

You can see the four shiny pivot points. The two on the left are for the clutch and the other two for the brake pedal. There is wear on the end of the shaft where the outer clutch bush is located. There is no wear at all on the shaft where the brake pedal pivots. The replacement of the clutch bushes alone would not be sufficient as the shaft wear at the end bush is reasonably pronounced. The overall lack of wear on the shaft is a testament to the standard of metallurgy employed at The Works.

It is possible to reverse the shaft and use the unworn section however the smaller hole can't be enlarged due the hardness of the metal. If the shaft is to be reused then a new fixing method to replace the little bolt at the chassis end will need to be employed. Large split pins (3.2 x 63mm)

I chose to purchase a NOS shaft and a set of bushes in order to complete the overhaul.

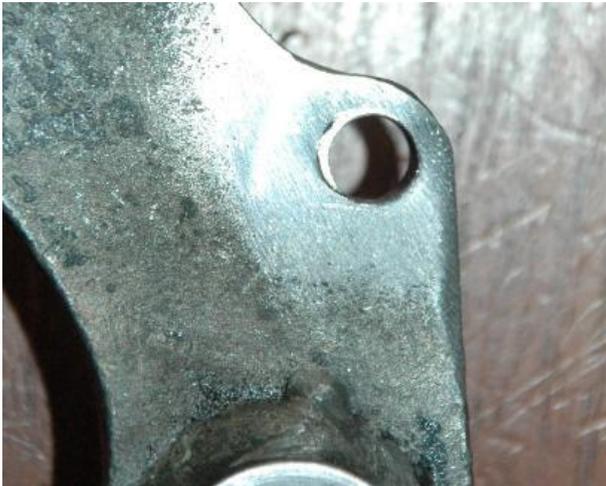
The fork mounting hole on the clutch pedal had become quite oval and leading inside edge was thin. This was remedied by filling the hole with weld and redrilling. The image to the left shows the repair. There was no wear on the brake pedal.
