The Newsletter of the Alvis Car Club of Victoria

OCTOBER 2015

IN THE WORKSHOP

BIG RED RUNNING ON WATER!

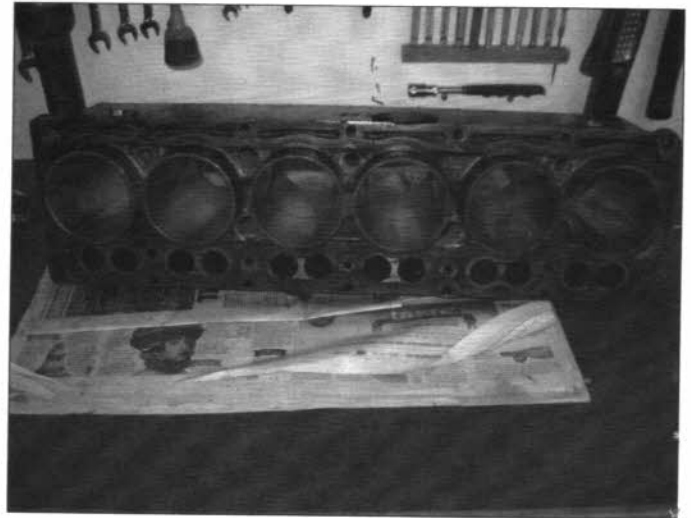
Fortunately I removed all the others. Two were like cheese and the others quite badly corroded.

The block with 6 of its plugs removed

A decision was made to remove the block and replace all the core plugs.

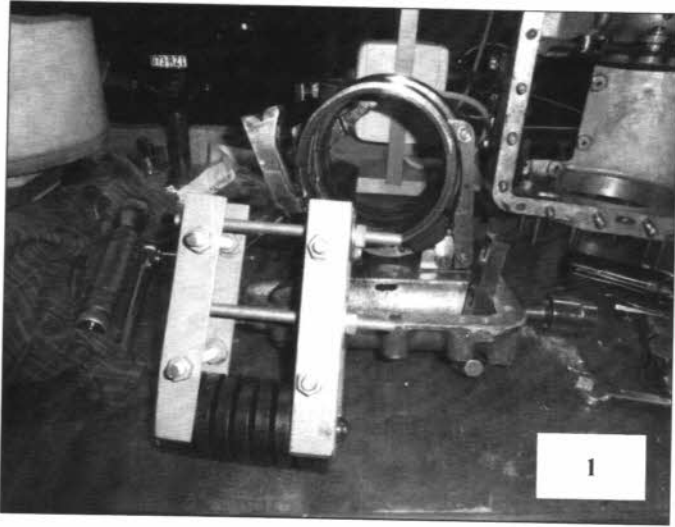
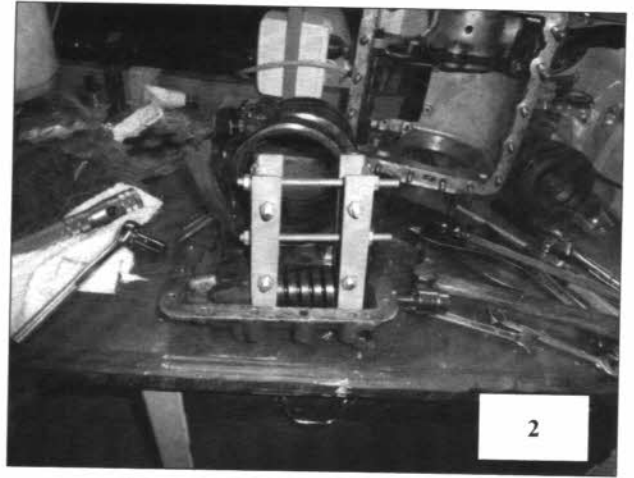
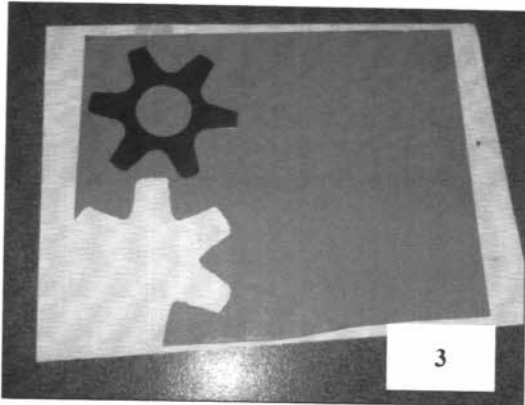
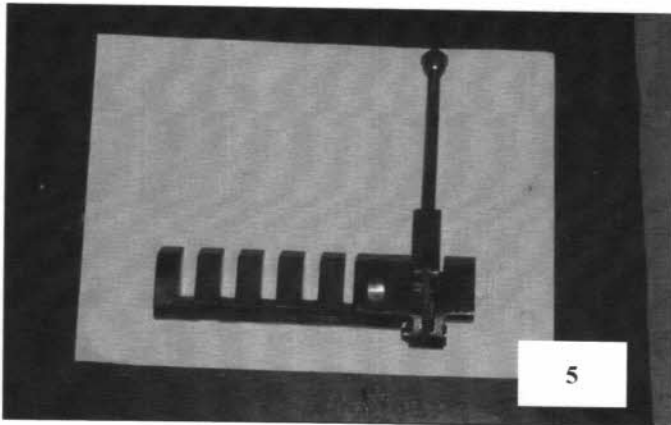
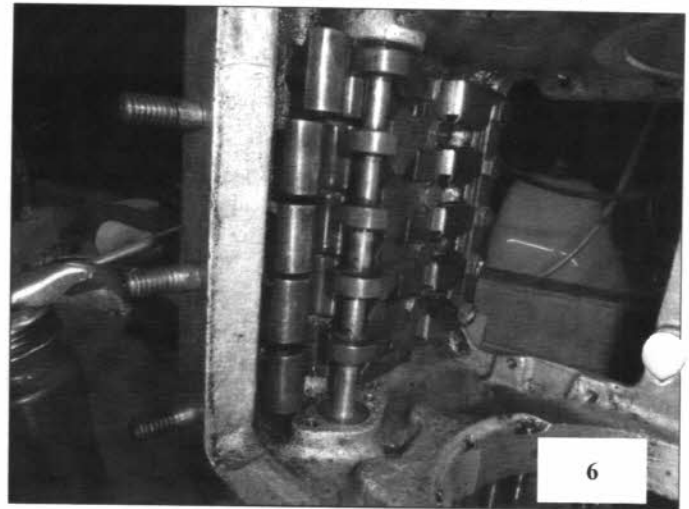
Photos -

The reason for it beginning to slip after the Mt Mee road run was found to be my home-made star spring. This had compressed in a vice OK before the box was assembled, but in service it was found to bind. I did not appreciate that the spring pressure which engages the top gear cone is not enough to properly compress this slightly heavier spring. A minimal amount of wear on the

- 1 & 2 Removing the Main Spring using Special Tool (Design from Peter Meyer)
- 3 Star Spring hand cut from stock (Laser Cutters were not interested in a one off)
- 4 Star Spring fitted to the 4th gear cone
- 5 Busbar which transfers the Main Spring pressure to the gear bands and cone
- 6 The New Camshaft or Selector Shaft installed (Reverse selected)
- 7 The Old Camshaft - note 'repairs'
- 8 The Band Stabilizer with aluminium spring blocks

I have now remade this spring in lighter material. I have also had the main spring tested for pressure at measured lengths as per Peter's specification. I have remade the items damaged by the gears slipping. These are the third gear drum bush, the distance washer between the second and third drum and the star spring distance piece, which was made to Peter's instruction.
