The Austral Alvist's Aide

BULLETIN
of the
ALVIS CAR CLUB
VICTORIA

ADJUSTMENT OF BRAKE LINKAGE ON TA 14.

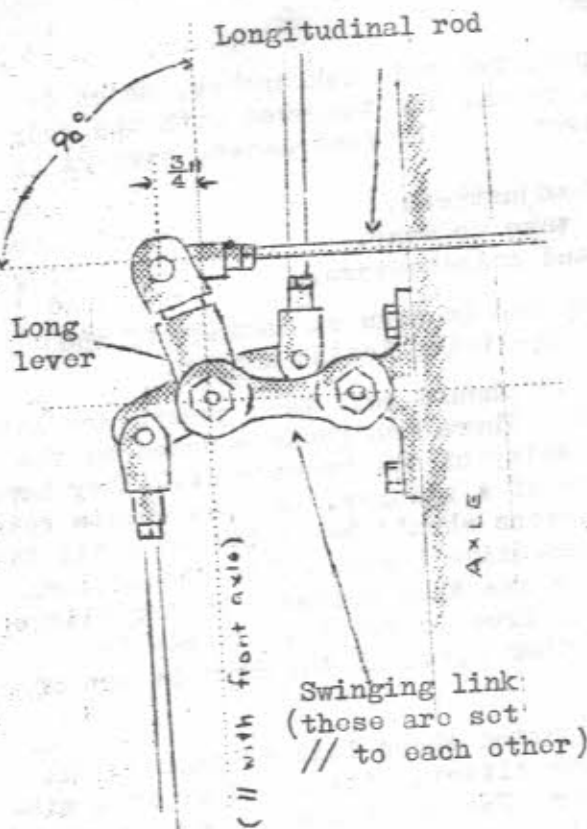
Now, reconnect the transverse rods on the front compensators, and adjust each by means of its screwed clevis ends (If never tampered with, this should not be necessary) so that the long lever of the compensator, to which the longitudinal rod is attached, is $5/8$ " to $3/4$ " before a line parallel to the front axle, and the swinging link of the compensator is parallel to the longitudinal rod. (Refer to diagram). Take great care to achieve the correct geometry here. When satisfied, tighten up the locknuts.

Summary: The important aim of this procedure is to ensure the correct geometry of the compensator linkages. To re-iterate, the long lever of the compensator (which attaches to the longitudinal rods) must be set $\frac{3}{4}$ " ahead of the line parallel with the axle. Note, that the rear compensator is set similarly, except that the distance is $\frac{3}{4}$ " behind the parallel line.

Now, connect the longitudinal rods from front axle compensator to the front relay lever, and to the reversing lever at the base of the pedal lever and centrally placed to it. Adjust these rods until the relay lever lies just forward of the vertical and the lower end of the reversing lever is $5/8$ " forward of the vertical. Tighten up the locknuts.

Next, connect the rod from the lower part of the balance lever to the lower hole in the rear relay lever nearest to the pivot, and adjust the rod so that the relay lever lies $\frac{3}{4}$ " behind a line passing through the pivot and parallel to the rear axle.
