ALVIS WORKSHOP

Three Litre {TA-TC} Clutch and Brake pedal assembly overhaul. Richard Wallach

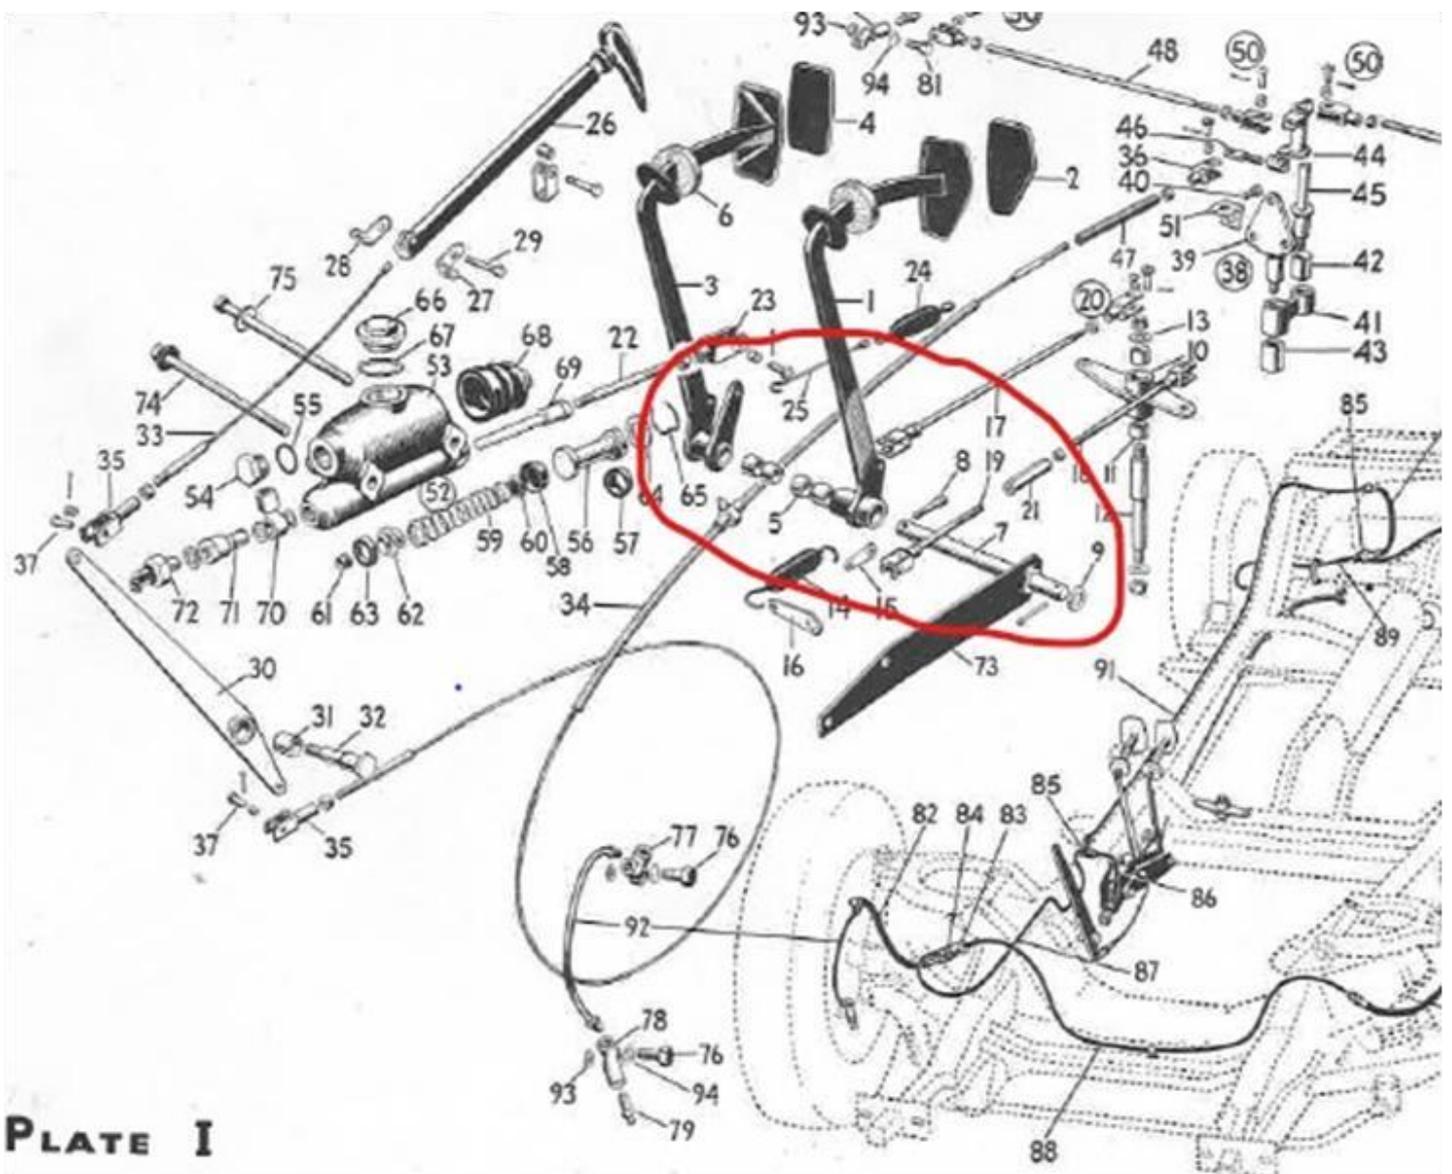
After sixty eight years the pedal assembly is being pulled down for the first time. In a previous article I discussed the replacement of the sintered bushings in the clutch reversing lever. These bushes are also used in both brake and clutch pedals as well as on the hand brake lever. To recap these bronze bushings are made of tiny metal spheres compressed into the required size. This type of bush absorbs and retains oil. They were designed to last the life of the car without further replenishment. The clutch and brake pedals have a pair each and they pivot on the pedal shaft {part no.C5917 – I-7 in the Catalogue of Spare Parts}. The image below, taken from the catalogue (page 42) provides an excellent representation of the relationship of the various parts.
